Exterior Noise Assessment

AAPS - Thurston Elementary School

IMEG #24001204.05

IMEG #24001204.05
June 4, 2024

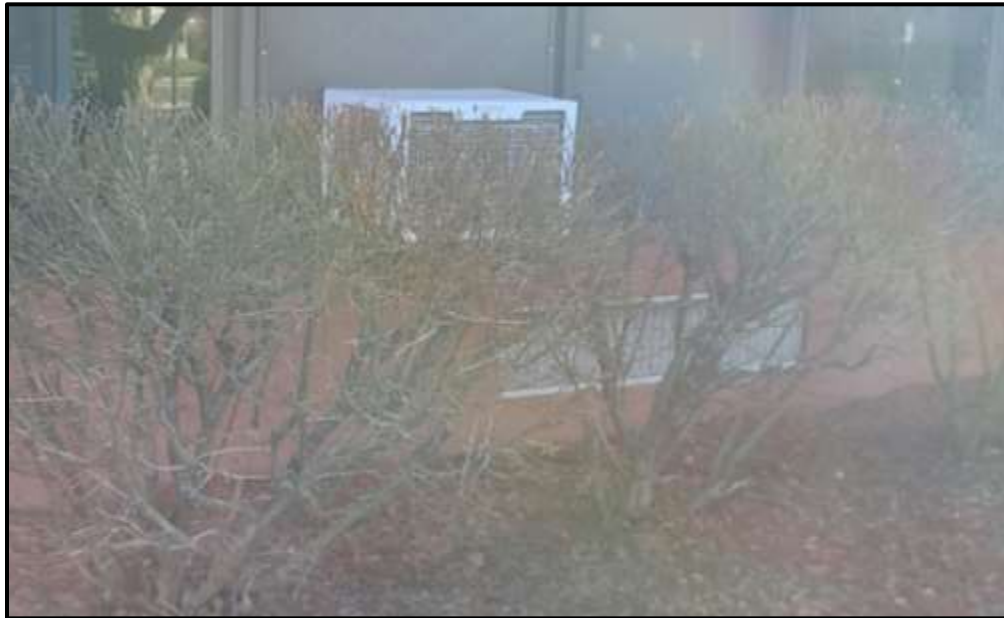
5. Window air conditioning units were in nearly all rooms throughout the building, as seen in Figure 2. One window unit was running during the site survey and measured 70 dBA at the source on the exterior side, as seen in Figure 1. This is a very high noise level, particularly outside primary education rooms. Noise from the exterior will flank into the building through the glazing and window frames.

Figure 1: Measured Air Conditioning Unit in Courtyard

8. Exterior noise above 57 dBA requires a verification measurement of the façade that exterior noise is abated to attain maximum interior background noise levels (40 dBA total). Measurements near the building and building support equipment readily surpassed this level. New design and construction should include attention to noise generated by building support equipment, the location of the equipment, and acoustical abatement design for the equipment. Generated noise levels may require verification measurements at project completion to confirm attenuation metrics (STC or OITC). ASNI S12.60 recommends STC and OITC metrics for façade abatement.

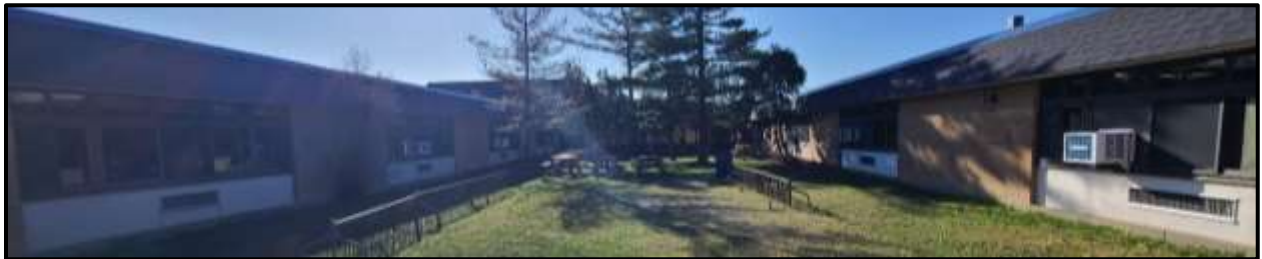
2. Window air conditioning units that were seen in nearly every classroom at the school. One running unit was measured at 70 dBA at the source. These units are loud and when all are turned on will create a louder environment, particularly in the courtyard where many units were located in close proximity and a semi enclosed environment.

Figure 2: Courtyard with Air Conditioning Units in Every Classroom

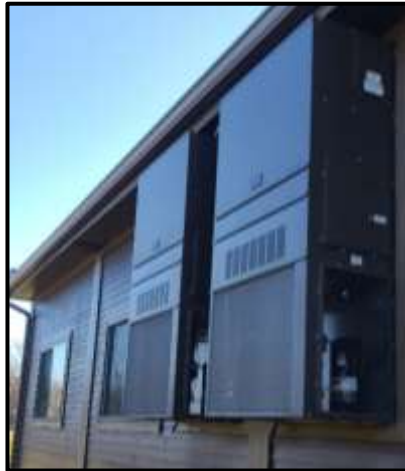
6. Thurston Elementary School had a detached building addition to the north of the main building, connected by a covered exterior walkway. This addition had dedicated building support services including heating and cooling mechanical unit both on the interior and exterior of the building. These units generated a large amount of noise exterior to the building. The northwest side of the addition featured two (2) mechanical units mounted high on the exterior wall, as seen in Figure 3. The southeast side of the addition featured three (3) similar units mounted in the same fashion, as seen in Figure 4 and Figure 5. These were not running during time of site survey but may produce occasional or continuous noise during operation.

Figure 3: Mechanical Units on Northwest Addition Exterior

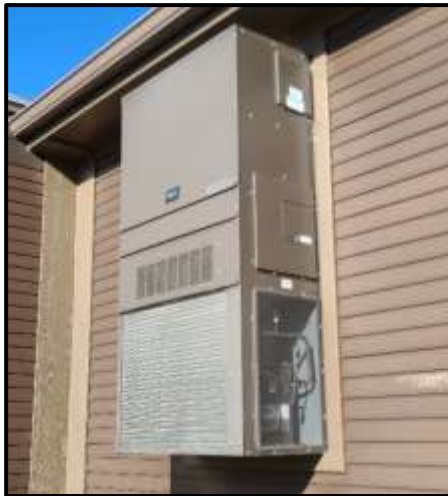
Figure 4: Single Mechanical Unit on Southeast Addition Exterior

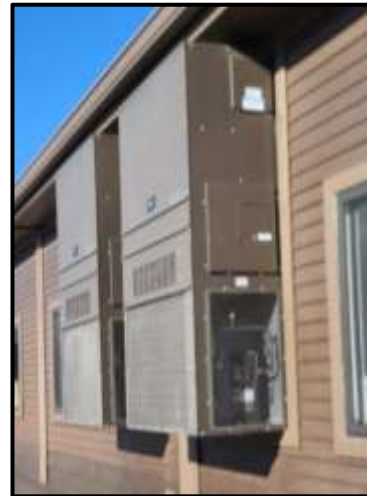
Figure 5: Double Mechanical Unit on Southeast Addition Exterior

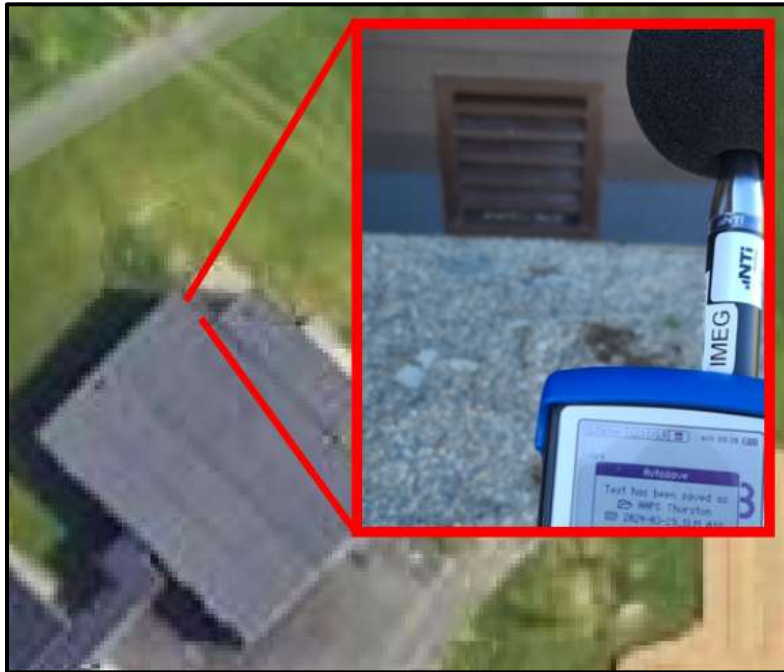
7. The north corner of the addition featured two (2) mechanical exhaust louvres from interior mechanical units, as seen in Figure 6 and Figure 7. These produced sound levels up to 66 dBA and overpowered all other sound sources in the area.

Figure 6: First Loud Exhaust Louvres

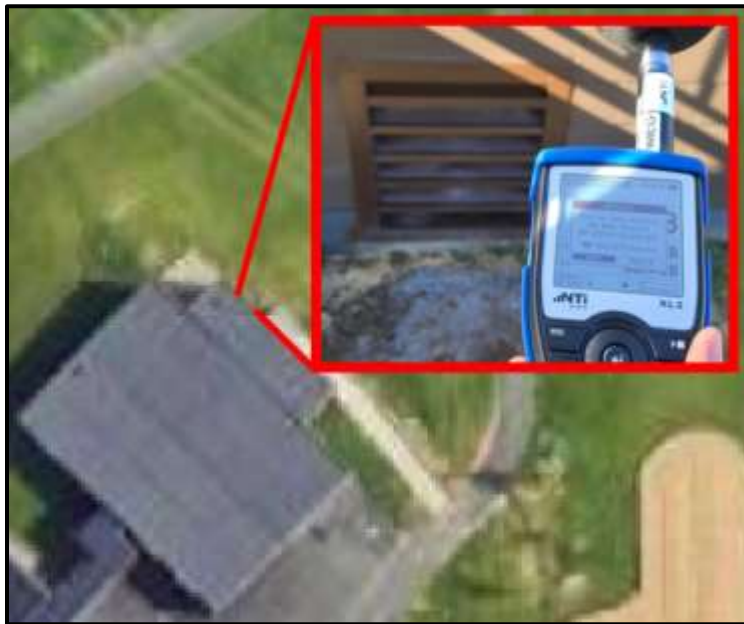
Figure 7: Second Loud Exhaust Louvre

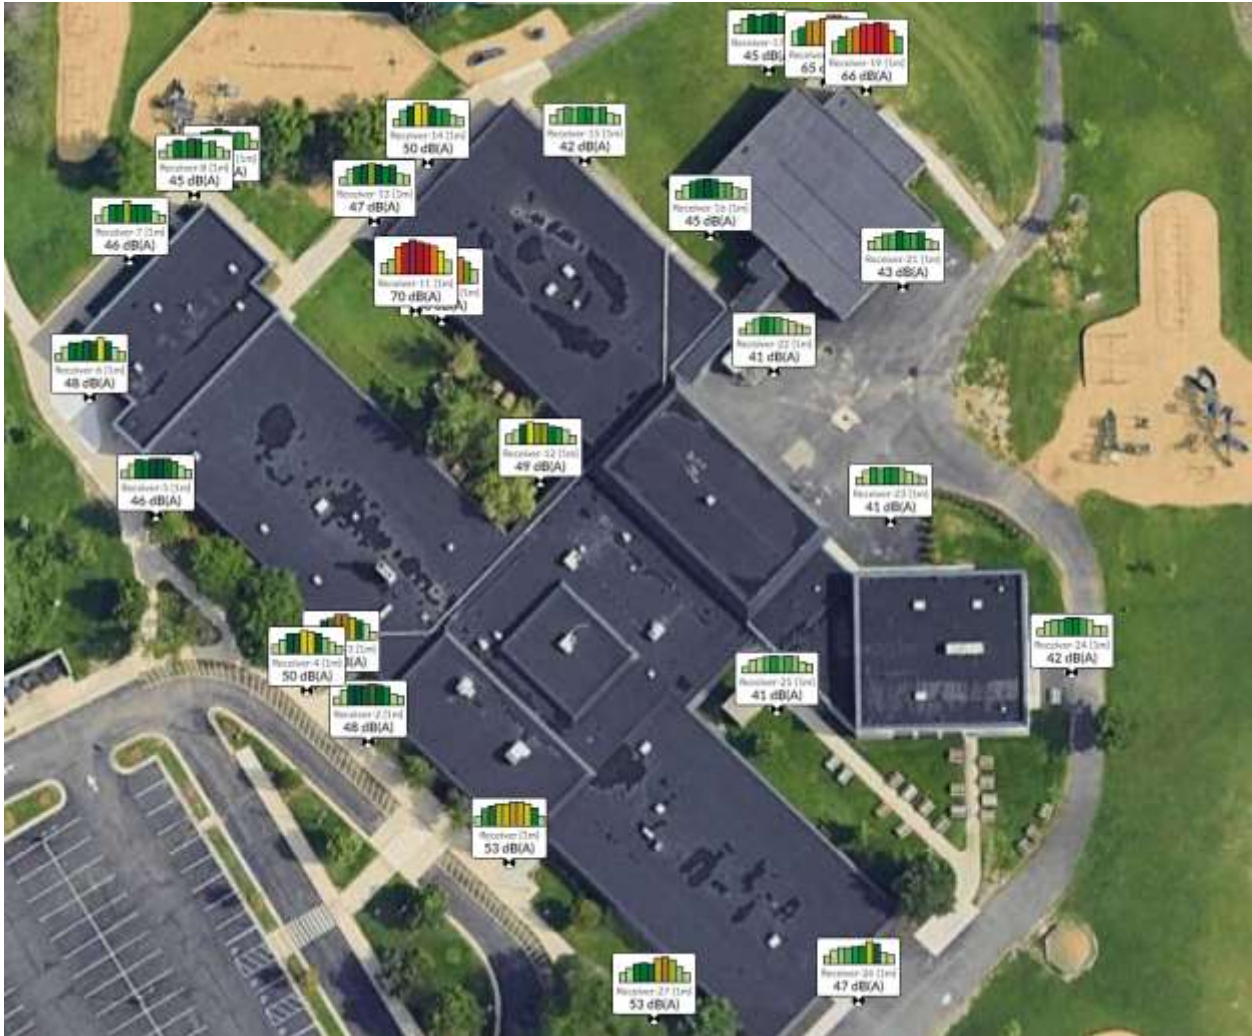
9. The measured sound levels at the school are shown below in Figure 8: Measured Exterior Sound Levels.

Figure 8: Measured Exterior Sound Levels
